Prepared by:
Proctor Engineering Group, Ltd.
San Rafael, CA 94901
(415) 451-2480

**Ohio Department of Development
Office of Energy Efficiency
Home Weatherization Assistance Program
Field Site Investigation**

Prepared for:
Ohio Department of Development
Office of Energy Efficiency

Final Report
August 1998

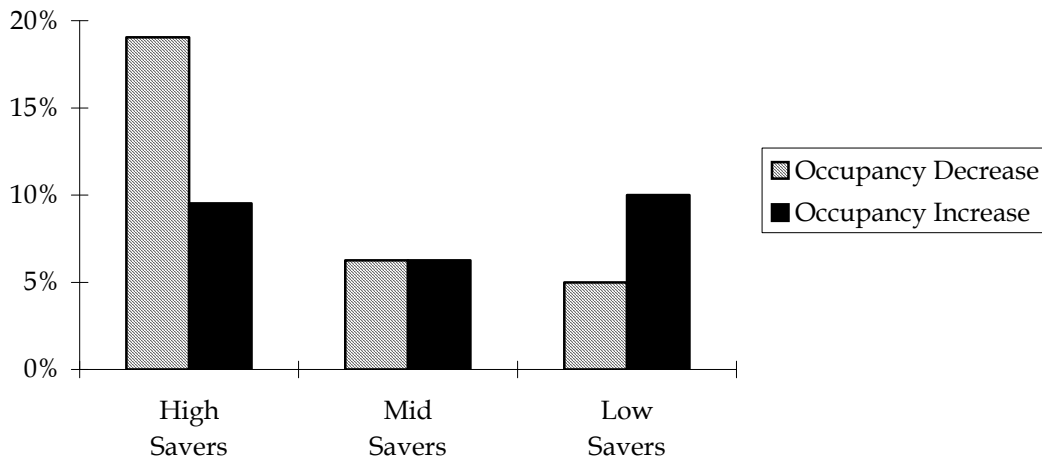
Figure 1-1 Occupant Reported Occupancy Changes Since Weatherization

As illustrated by Figure 1-1, a contributor to high savings may be the reduction in household occupancy.

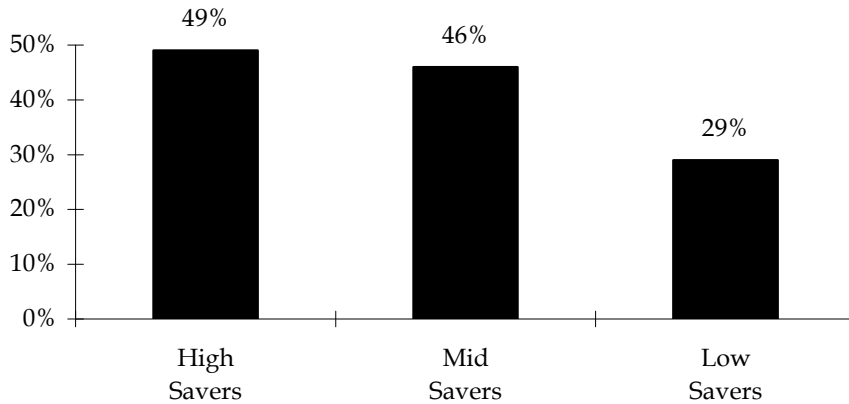
Figure 1-4 Percent of Reduction in Available Air Leakage

The agency reported blower door readings indicate that they were most successful at reducing the air leakage of the high savers group. The mid savers group had nearly identical amounts of reduction while the low savers group did not fare as well. The agencies reported capturing 49% of the available reduction on the high saver group, 46% on the mid saver group and only 29% on the low saver group. Available reduction is defined as the amount of leakage reduction possible after subtracting the minimum ventilation required. Figure 1-4 shows the percentage of available reduction in air leakage captured for each of the savings groups.

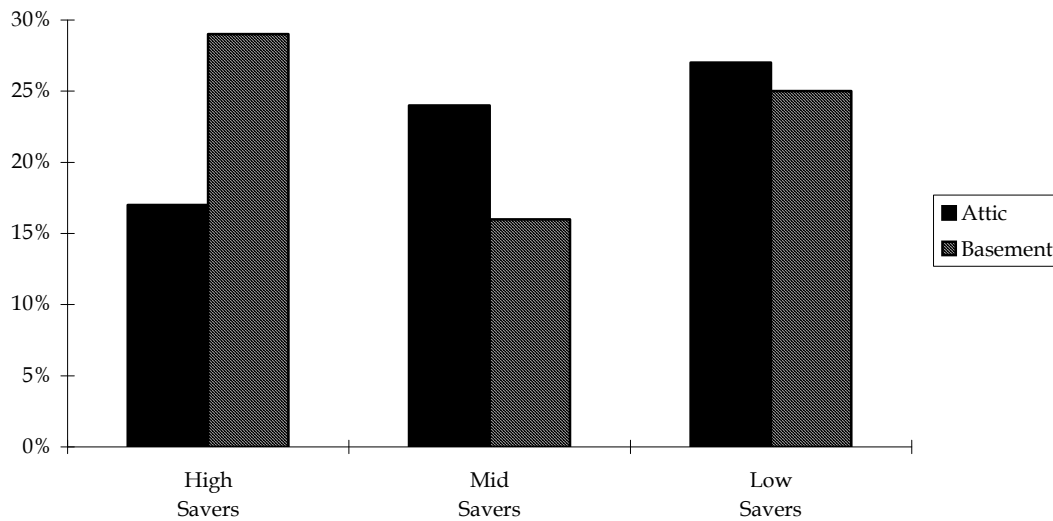
Figure 1-5 Percent of Remaining Air Leakage to Attic and Basement

Figure 1-5 demonstrates the agencies' success in reducing the leakage to the attics of the high saver group as compared to the mid and low savers. The choice to concentrate on air sealing the attic instead of the conditioned basement is also shown on the high savers.

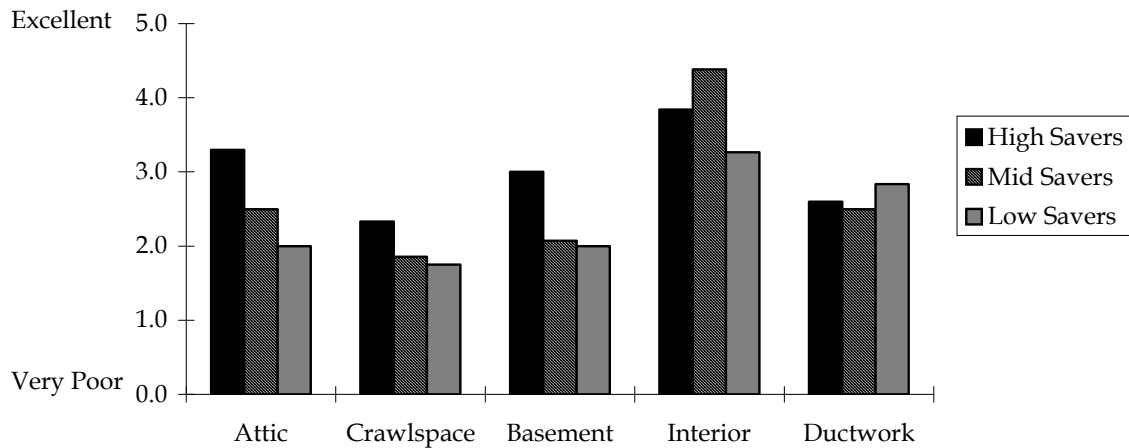
Figure 1-6 Quality of Air Sealing Technical Assessment and Work Performed

Figure 1-6 reveals the superior quality of technical assessment and work performed on the high saver group. The areas that are the most important in air sealing are at the top and bottom of the home. As shown in figure 1-6 the high saver group received the highest quality assessment and air sealing work in the attic and crawlspace/basement.

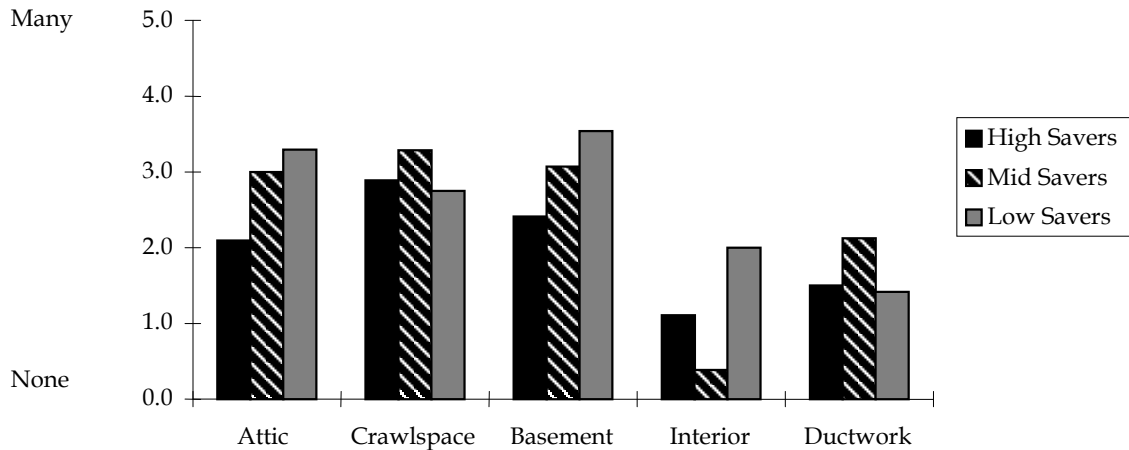
Figure 1-7 Missed Opportunities for Performing Air Sealing Work

Figure 1-7 indicates that generally the opportunities were better captured on the high savers, while the low saver group had more potential for effective work.

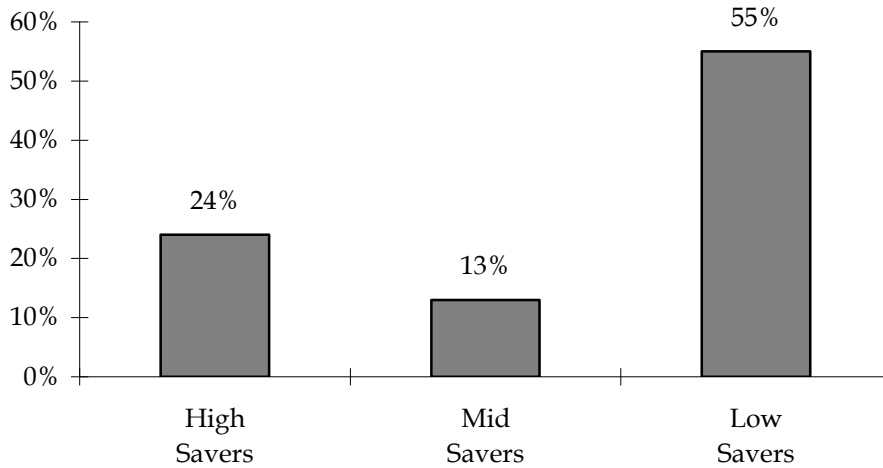
Figure 1-10 Percentage of Systems with a Measured High Heat Rise

An efficient forced air system should have a heat rise that falls within the manufacturers' suggested range. Generally this is around 40°F to 80°F. Checking the heat rise was not part of the furnace efficiency procedure during the 1994/95 HWAP. This procedure has only recently been added to the standard HWAP furnace procedure. Overall, 35% of the systems (17 of 49) had heat rises of greater than 80°F. The low savers tended to have higher heat rises. Fifty three percent of the low savers (10 of 19) had high heat rises, while the mid and high savers had 14% (2 of 14) and 29% (5 of 17) respectively. Generally, high heat rises tend to be caused by either dirty blower assemblies or low fan speeds. Eighty seven percent of the systems (13 of 15 with measured static pressures) with high heat rises had acceptable return side static pressures (not exceeding -50 pascals). This indicates that the design of the return systems is not restrictive and probably not

the cause of the high heat rise. Figure 1-10 illustrates the percentage of clients with high heat rises in each savings group.

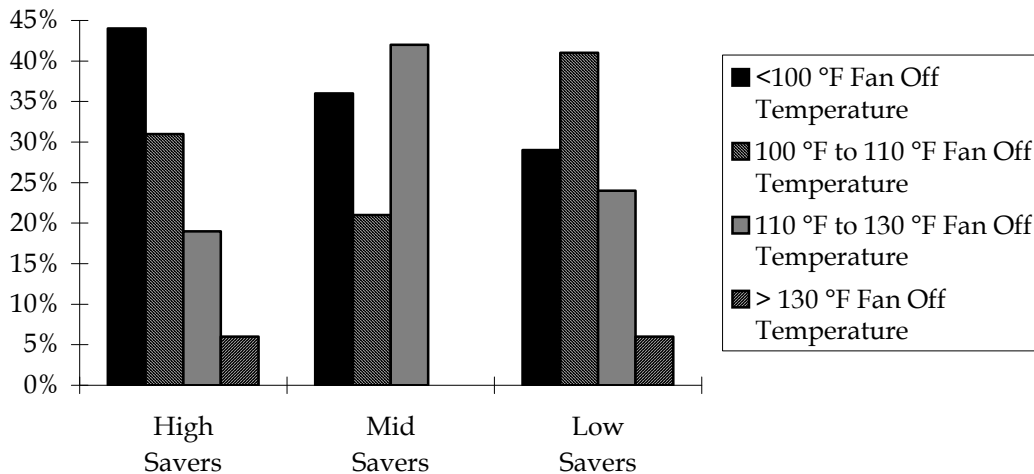
Figure 1-11 Measured Fan Off Temperatures by Savings Group

Sixty four percent of the systems (30 of 47) had fan off temperatures of 100°F or greater. Figure 1-11 shows the distribution of measured fan off temperatures.

The high saver group did tend to have lower fan off temperatures.. The mid saver group had a large portion of systems with fan off temperatures greater than 110°F. But the savings or lack of savings for any group can not be attributed to fan off temperatures since none of the participants had reported fan off temperature modifications.

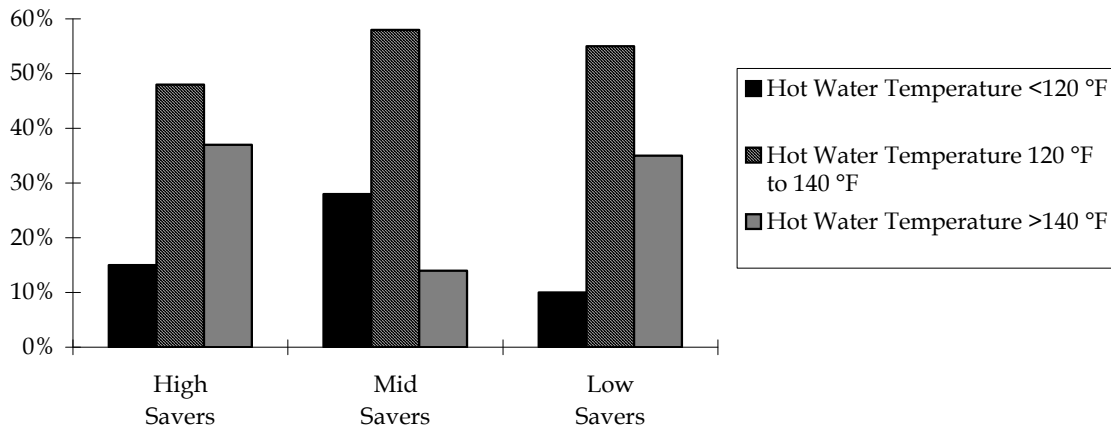
Figure 1-12 Measured Hot Water Temperatures by Savings Group

The average measured hot water was 131°F. Seventy five percent of the clients (41 of 55) maintain their hot water temperature at greater than 120°F. High and low savers were both likely to have high hot water temperatures. Seventy six percent of high savers (16 of 21) and 85% of low savers (17 of 20) had hot water temperatures of greater than 120°F. Figure 1-12 shows the distribution of measured hot water temperatures.
